CORROSION BEHAVIOUR OF SUBMARINE POWER CABLES IN SEAWATER ENVIRONMENT

Daniel ISUS, Juan D. MARTÍNEZ, General Cable, Manlleu, Barcelona (Spain), disus@generalcable.es, jdmartinez@generalcable.es

ABSTRACT

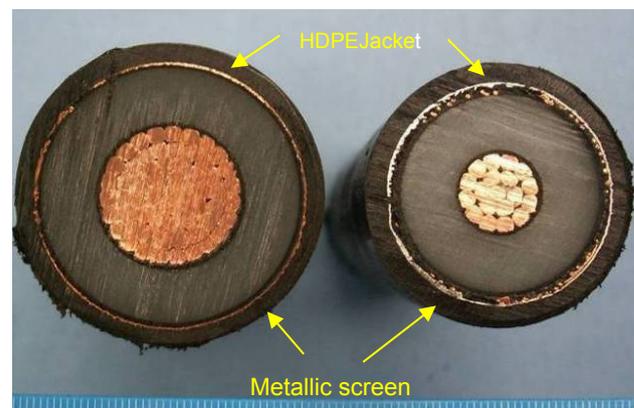
The two cable designs are shown in Fig. 1.

Fig. 1: Cross section of the two single-core cables with aluminum sheet and copper wires (right) and with helicoidal copper tape (left)

Two single core cables with different metallic screens have been studied. One cable comprised of aluminum sheet and copper wires, and the other comprised of helicoidal copper tape. In the first cable design, the cross linked polyethylene (XLPE) layer between the copper wires and the aluminum tape, is not continuous, with some areas of the aluminum and copper wires in physical contact. Therefore, a risk of galvanic corrosion is not discarded if the aluminum tape (anodic or more electronegative) is shorted to the copper wires (cathodic or more electropositive).

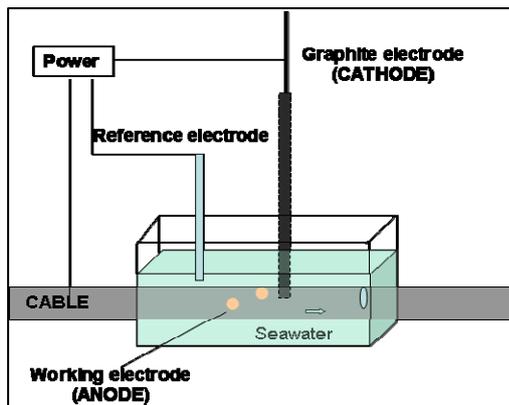
A design of the experimental set-up is given in Fig. 2.

Fig. 2: Experimental setup design for impressed anodic current tests of screen material with damaged outer jacket

Each cable sample was introduced in a plastic container filled with synthetic marine water Type 1, according to the ASTM D 1141 standard [3]. A small anodic current of 10mA was applied, by means of a potentiostat, between the metallic screen and a graphite counter.

The exposed copper was the anode; this is, the location where the current leaves, or what is the same, the zone that corrodes. The graphite electrode was the cathode, the place towards the electrons go. The impressed current was maintained till the exposed section of the damaged cable was totally corroded (or dissolved). Potential measurements were carried out during the test. Tests were conducted at 60°C and at atmospheric pressure.

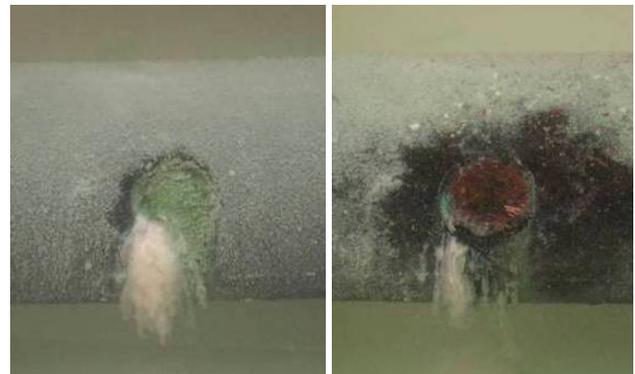
Fig. 3: Corrosion products on damaged jacket after 1128 hours of impressed anodic current test (left); same area after removal of corrosion products (right)

White voluminous corrosion products from the aluminum tape were observed right from the beginning of the test. However, greenish corrosion products due to copper corrosion were only detected after approximately 750 hours testing. After 1200 hours almost all of the exposed copper was dissolved (Fig. 3).

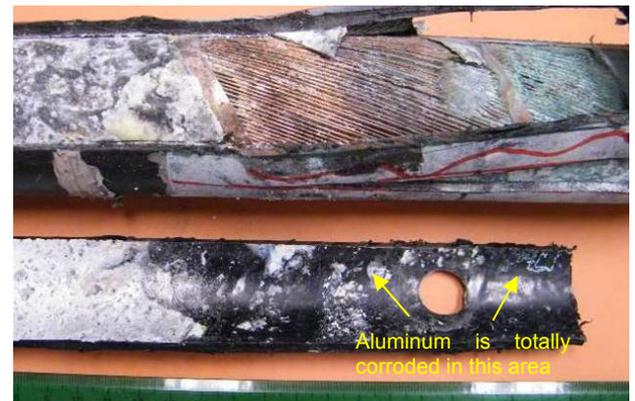
Fig. 4: Dissection of aluminum + copper wire screen cable after impressed anodic current test

At the end of the test, the cable sample was examined for corrosion progression under the HDPE jacket (Fig. 4). No swelling was observed on the tested cable. The examination of the tested cable indicated a total dissolution of the copper wires in the area exposed to seawater, this corrosion being mainly circumscribed to this punctured area. For the aluminum tape, significant corrosion damage was observed even under the HDPE jacket.

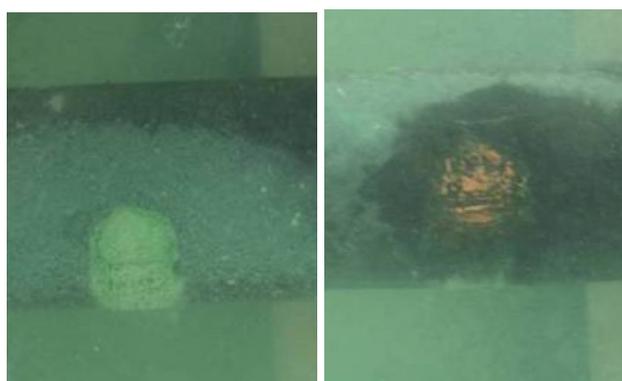
Fig. 5: Corrosion products on damaged jacket after 336 hours of impressed anodic current test (left); same area after removal of corrosion products (right)

Greenish copper corrosion products were detected just after 30 hours testing. After testing during 336 hours a significant corrosion of the copper tape was observed in the area exposed to the seawater (Fig. 5).

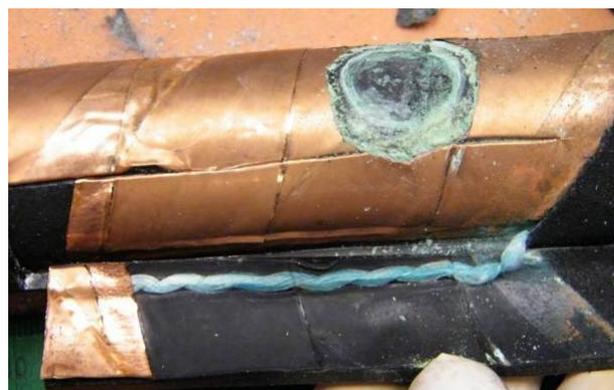
Fig. 6: Dissection of helicoidal copper screen cable after impressed anodic current test

At the conclusion of the test, the cable sample was examined for corrosion progression under the HDPE jacket (Fig. 6). Although a total dissolution of the copper tape was observed in the area exposed to seawater, the corrosion progression under the HDPE jacket was not detected. No swelling was observed on the outer HDPE jacket of the damaged cable.

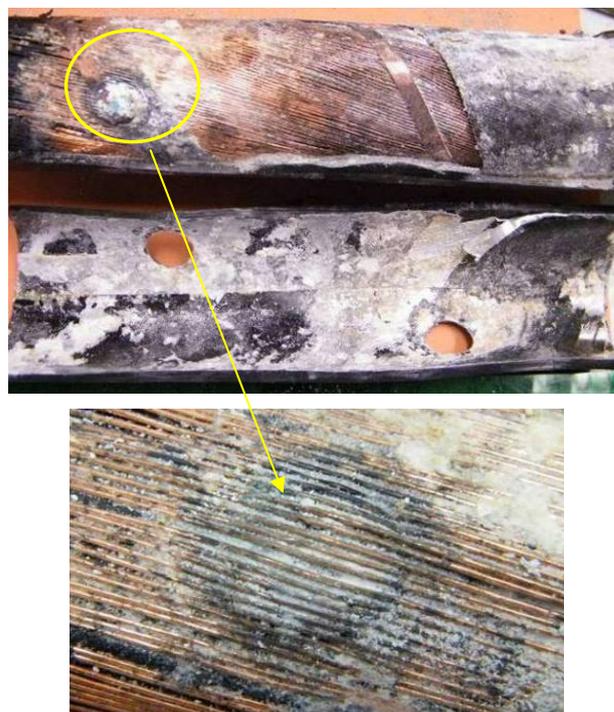
Fig. 7: Dissection of damaged jacket after impressed anodic current test

Voluminous white corrosion products from aluminum were observed just 20 hours after test initiation, whereas copper wires remained practically uncorroded, even after 2200 hours of testing. The absence of corrosion in the exposed copper wires could explain the almost invariable values for the electrical resistance of the copper screen.

At the end of the test the cable was cut up for corrosion evaluation (Fig. 7). No swelling of the outer HDPE jacket was observed.

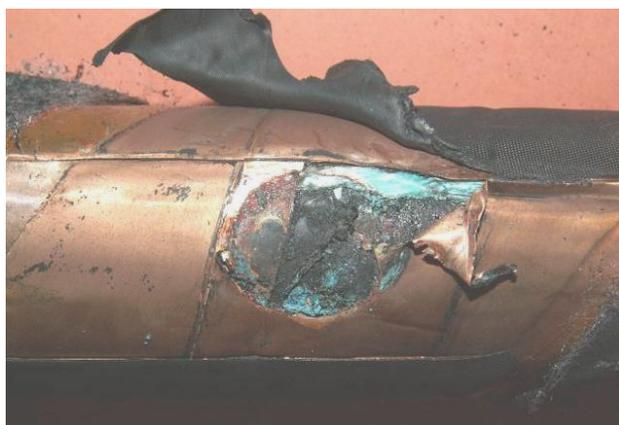
Fig. 8: Helicoidal copper screen cable after 1968 hours of immersion in synthetic seawater. Corrosion products have been partially removed

First signs of greenish copper corrosion products were detected after approximately 300 hours of seawater exposure. At the conclusion of the test, non corroded copper fragments were observed in the punctured holes (Fig. 8).

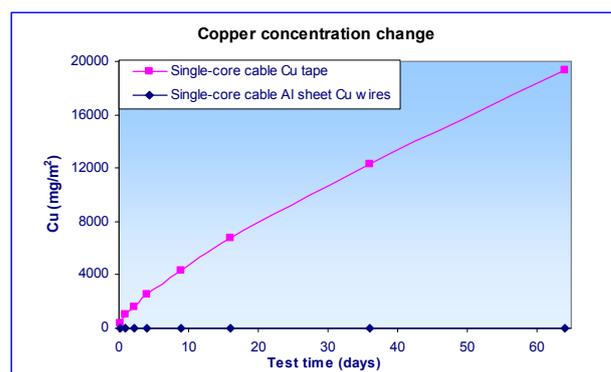
Fig. 9: Copper concentration changes

The changes in the concentration of copper and aluminum in the two eluates are given in Figs. 9-10.

Whereas the cable with the copper tape had an increasing trend in copper concentration, the cable with aluminum foil + copper wires gave significant quantities of aluminum but no sign of copper. Again, this behaviour is attributed to a galvanic effect.

In both cases, the migration rate was significantly fast. The aluminum concentration was stabilized around 719 mg/m². On the other hand, the copper concentration in the case of single-core cable with copper tape showed a rapid increase without stabilization, and a continuous migration of copper to the seawater could be expected.

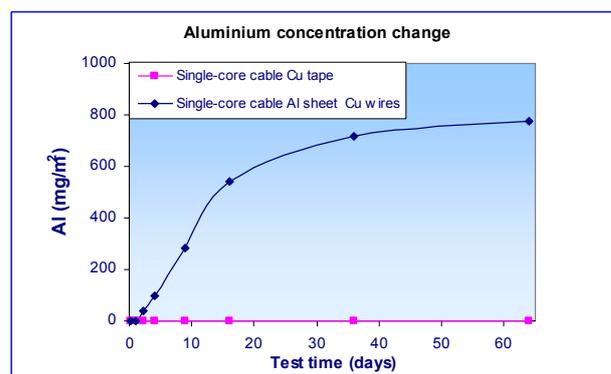
Fig. 10: Aluminum concentration changes
