How To Cut Downtime And Extend Cable Life

Surface mining cable care
and maintenance

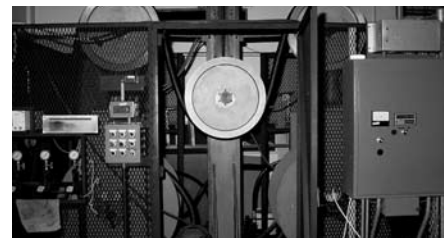
3) Mining Cable Test Lab

We believe no other supplier can offer you the services of a facility like this. Located at Marion, Indiana USA, we have all the test equipment necessary to simulate actual conditions in a mine. But with one important difference—our Portable Cable Lab can test a cable to destruction in a fraction of the time it would take under normal field conditions. Yet we can accurately extrapolate the results, in terms of the type of end-use the cable is expected to receive.
